REPORT NO. NADC-MA-6716

16 APRIL 1968

EVALUATION AND COMPARISON OF THE CORROSION SUSCEPTIBILITIES OF 7178 ALUMINUM PLATE MATERIAL OF VARIOUS TEMPERS

Aero Materials Department

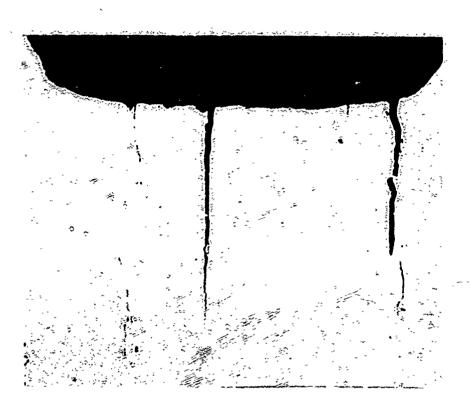
Optimum mechanical properties are obtained on the 7178 aluminum alloys when they are heat treated to the T651 temper but this temper is very susceptible to intergranular corrosion, stress corrosion cracking and exfoliation. The T651 specimens exhibited an acute sensitivity to stress corrosion cracking in the short transverse direction. Tuning fork specimens stressed to 75% of the long transverse yield strength failed after one day exposure to alternate immersion in 3½% NaCl solution. Figure 1 shows the cross section of a 7178-T651 tuning fork specimen; numerous intergranular stress corrosion cracks are seen emanating from the tensile surface. Susceptibilities to intergranular corrosion and exfoliation were quite evident after exposure to the salt spray environments, one acidified to a pH of 3.5 by additions of acetic acid, the other involving introduction of S02 gas. Figure 2 depicts the exfoliation that resulted from both salt spray exposures.

FIGURE 1 - 7178-T651 Alternate Immersion Stress Corrosion Test.
View: Short Transverse Cross Section of Tuning Fork
Specimen. Unetched 100X
